PRELIMINARY REPORT

ATF-5

ATF-5 REPORT

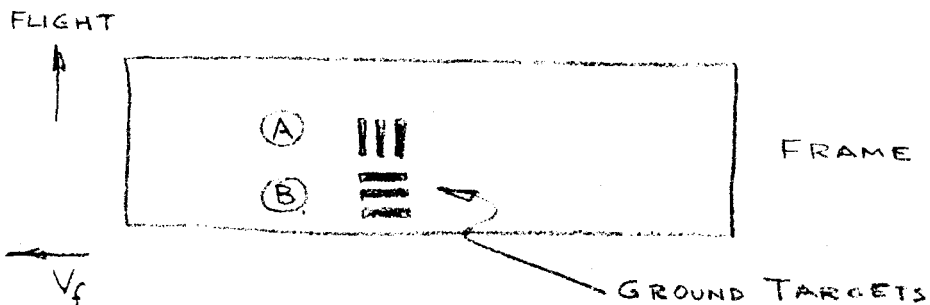
ATF-5
SCANNER PHASING
RUN 1

Scanners not phased properly. Forward scanner leading its correct position by 45° and aft scanner leading its correct position by 55° . This means that aft scanner was leading the forward scanner by 10° instead of $42\frac{1}{2}^{\circ}$. On ATF-4 the forward scanner was phased properly (to about $\pm 3^{\circ}$) and the aft was misphased (leading) 40° --the same condition as LTF-17.

- 5.1 Rephase scanners and check IMC, capping shutter phasing.
- 5.2 Implement correction of slit relay pulse (elements relay).
- 5.3 Check V/h sensor grid frequency, focus, wiring from interface package to system and test signal wiring.
- 5.4 Locate break in LVSYN test signal lead and correct.
- 5.5 Do not short cut ground check-out with Brush recorder.
- 5.6 Replace Natel Master Oscillator (spare available December 14th).
- 5.7 Institute search for cause of static (or pressure) marks.
- 5.8 Recommend fly same test again, after corrections.
